Wastewater Collection System Evaluation Survey Basin 7 Final Report

December 2010

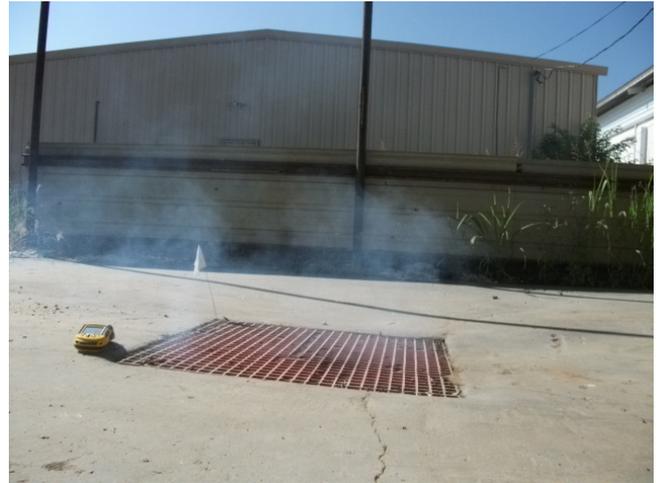
Area drain found during smoke testing. Upstream manhole
135601
