Wastewater Collection System Evaluation Survey Basin 6W Final Report

**Mr. Nick Williams, P.E.
Director of Public Works**

December 2016

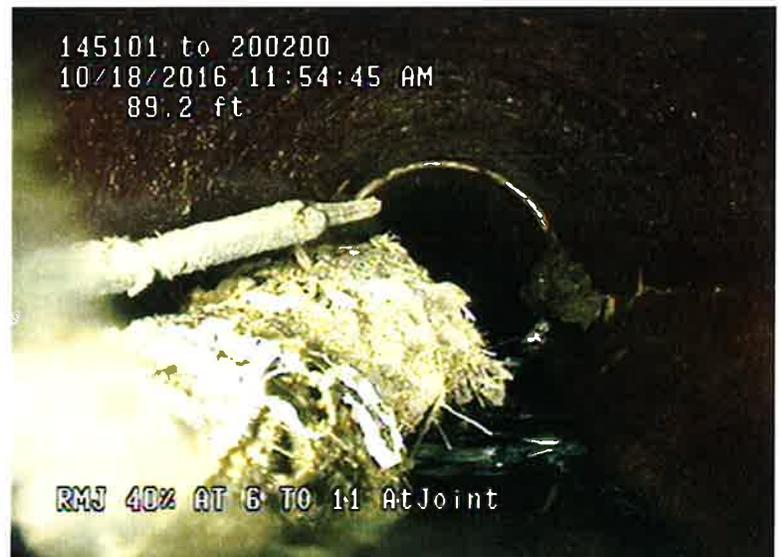
Line Segment 145101 to 200200
Root intrusion at pipe joint.

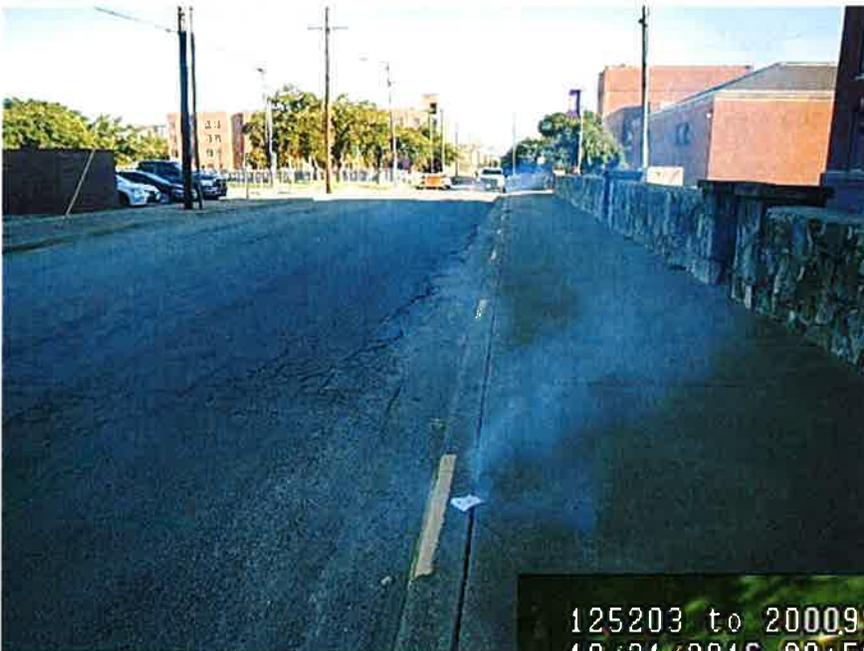
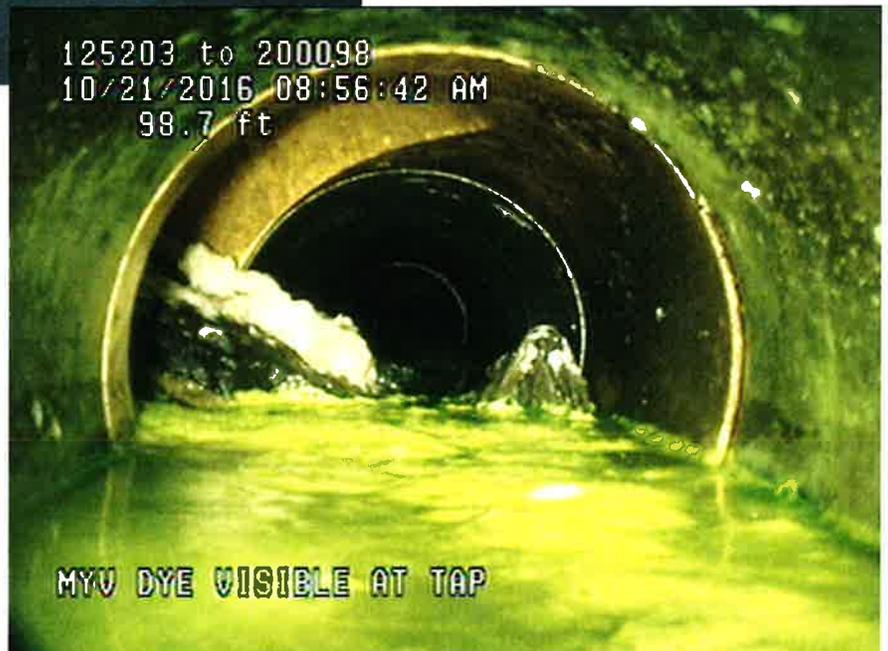
Positive dye test on defect identified during smoke testing. Dye test confirmed that the defect is on a private lateral connecting to the mainline sewer. Location: 300 Block of S. Lillian Street
