Wastewater Collection System Evaluation Survey Basin 10 Final Report

June 2009

Pipeline Analysis, LLC
Texas Registered Engineering Firm
F-006538

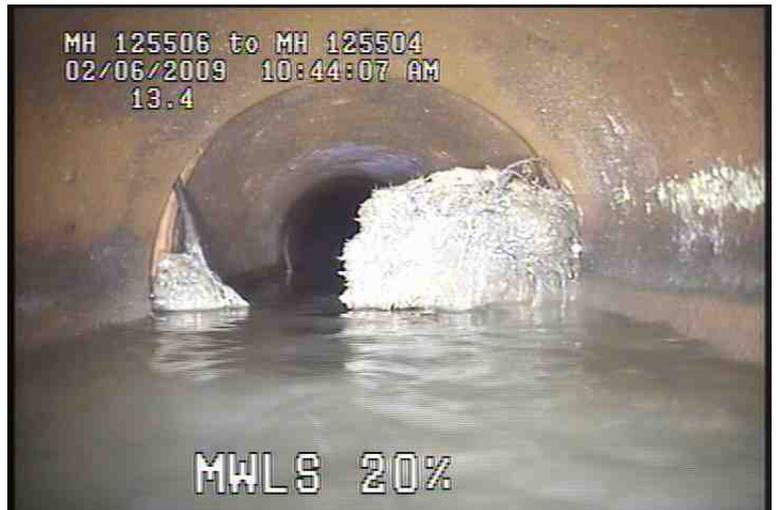
Root intrusion at pipe joint. Segment 125506-125504.

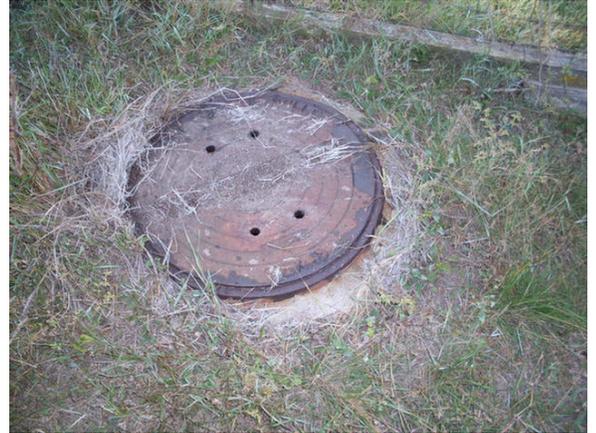
Basin 10
Manhole 136104 – Vented Cover

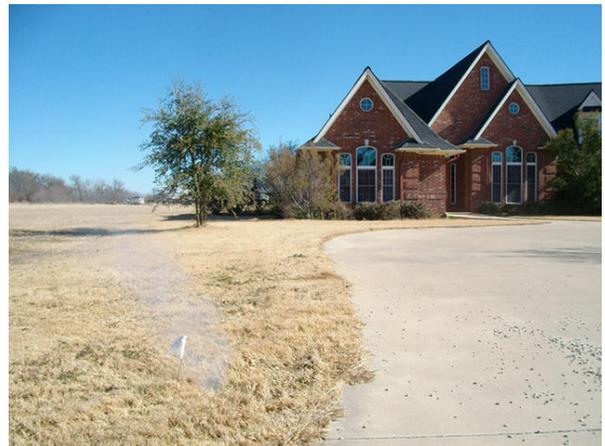
Private service line defect identified during smoke testing.

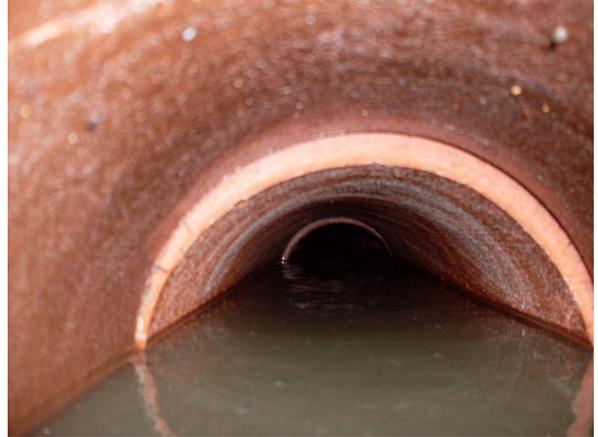
Minor offset pipe joint.
