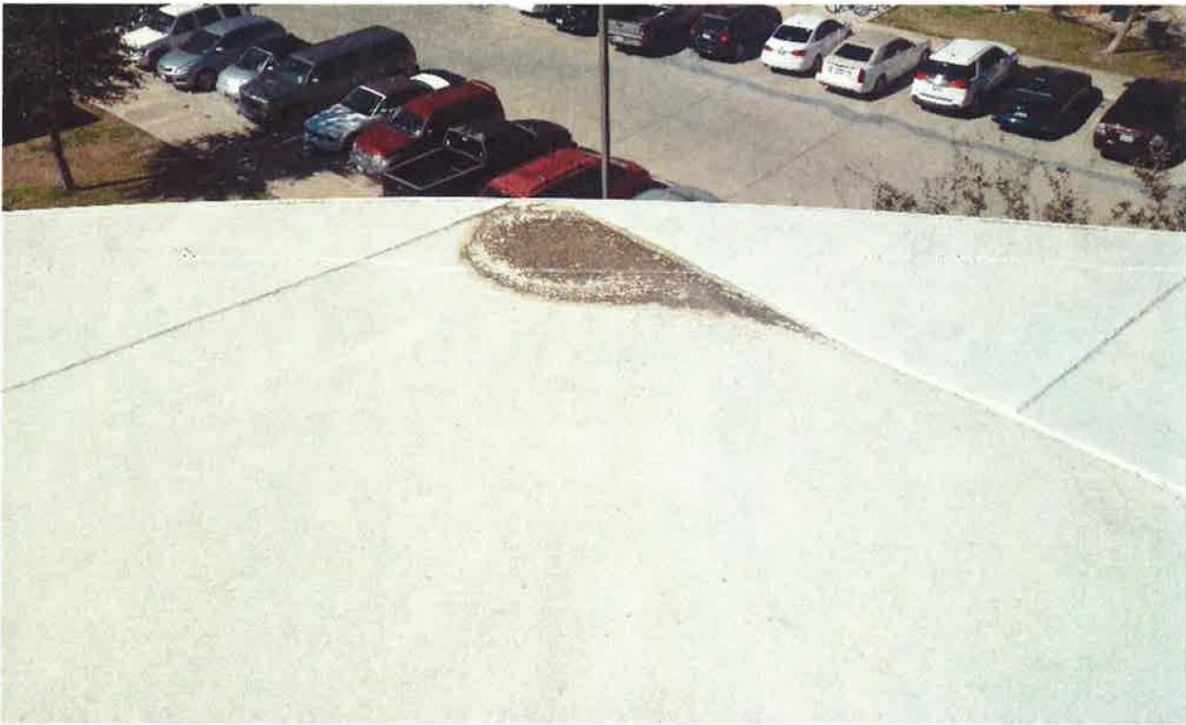
41. Ponding near roof perimeter .

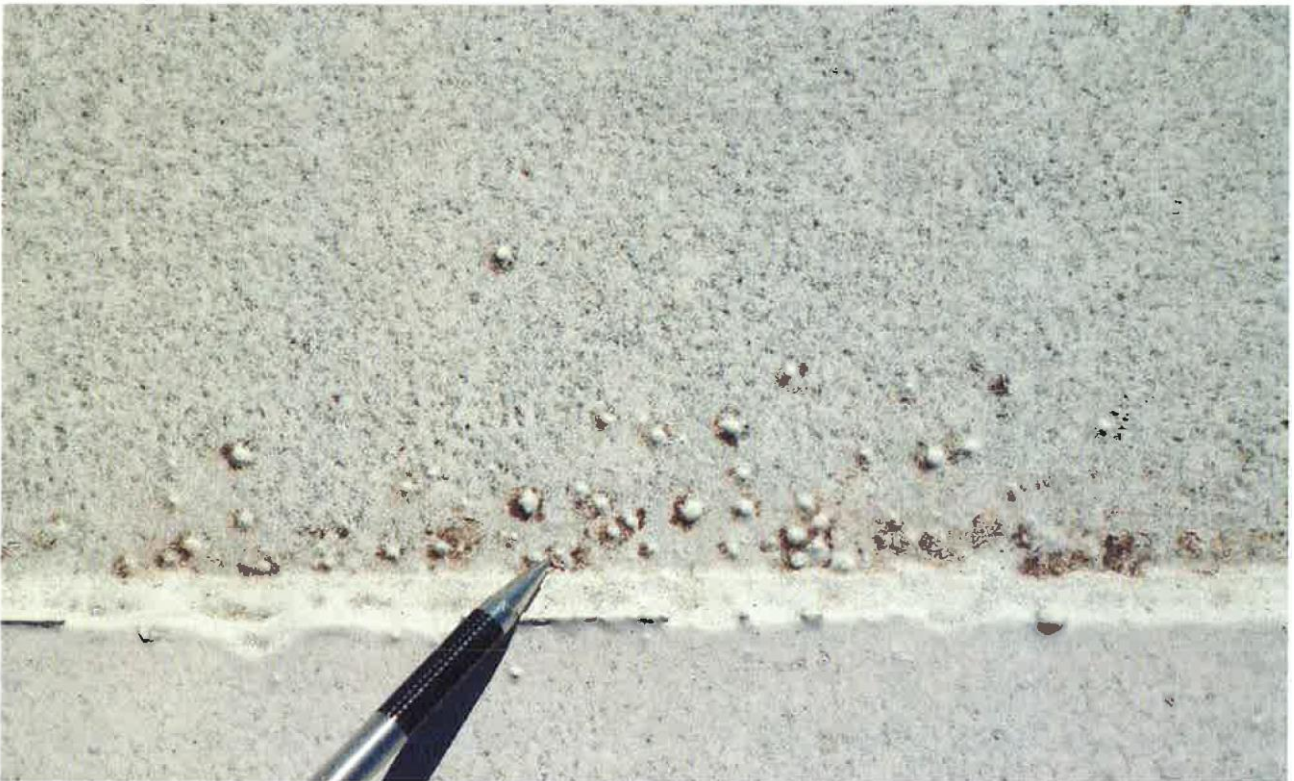
42. Weld spatter on roof

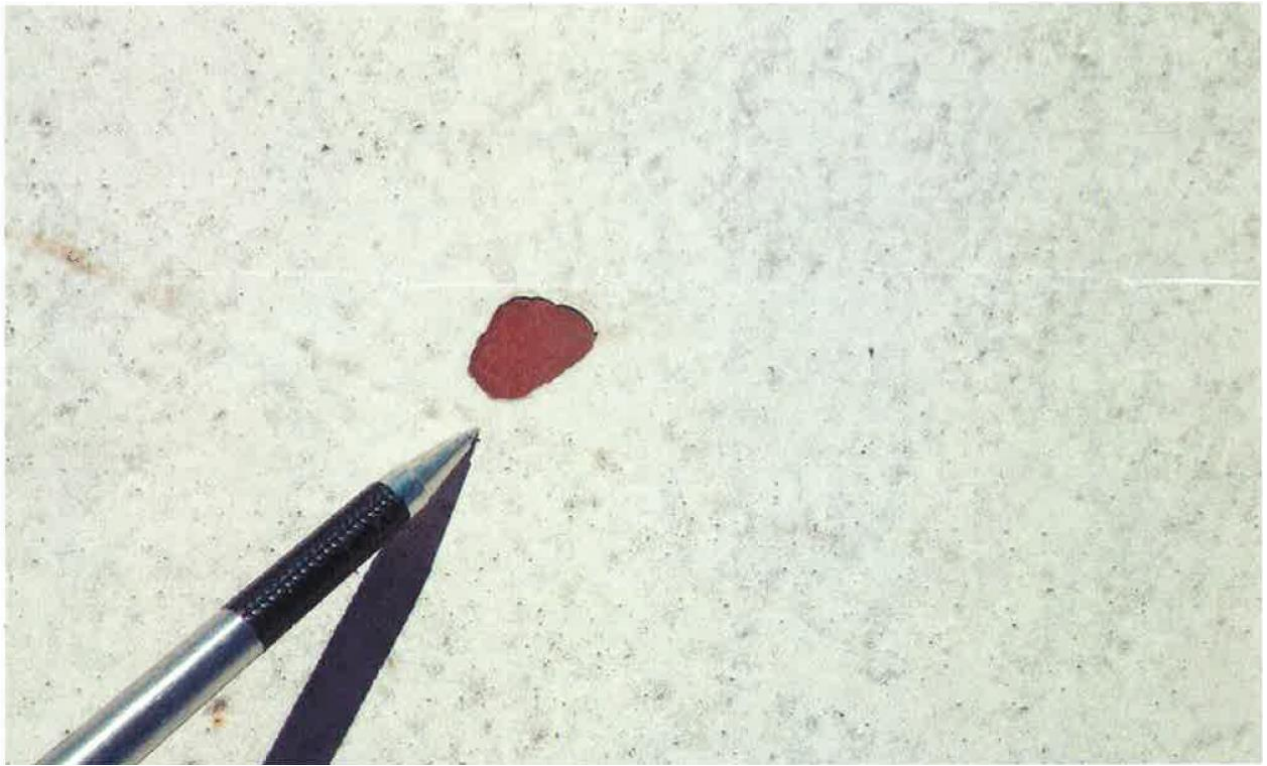
43. Peeled coating on roof.

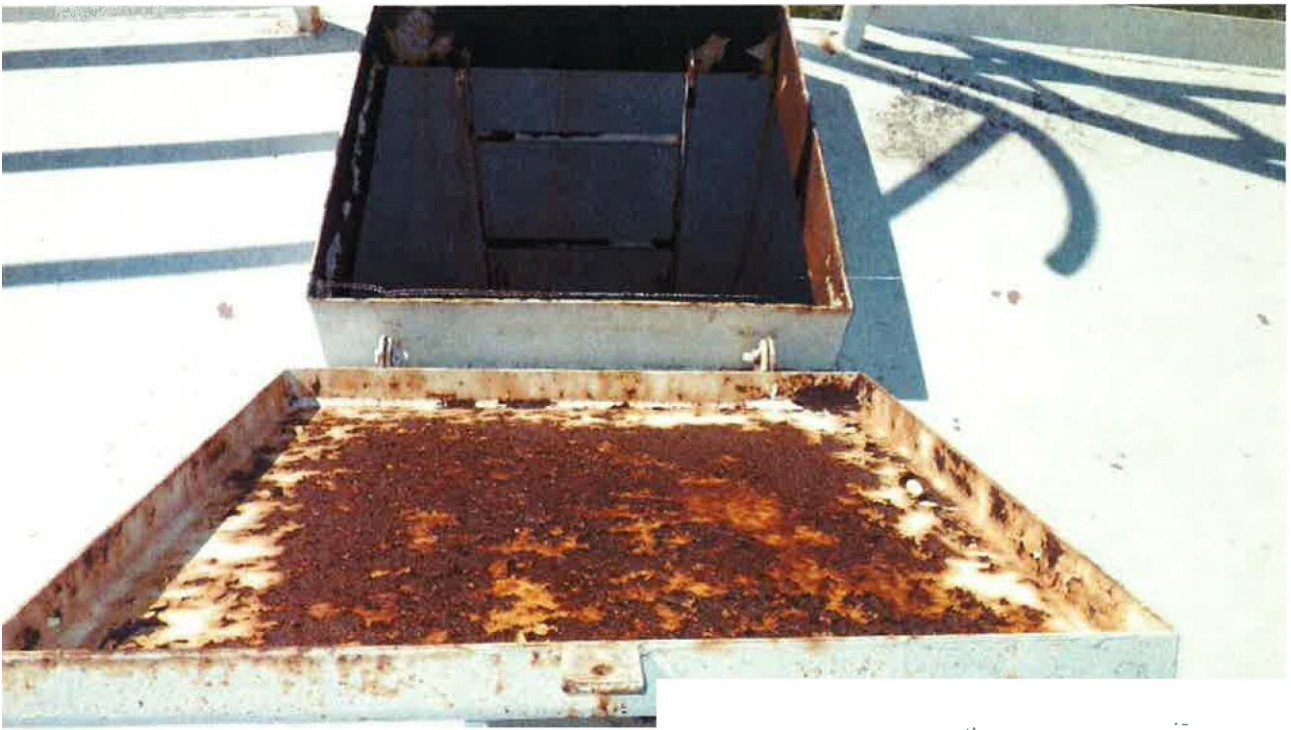
45. Roof manhole. Note corrosion on cover.

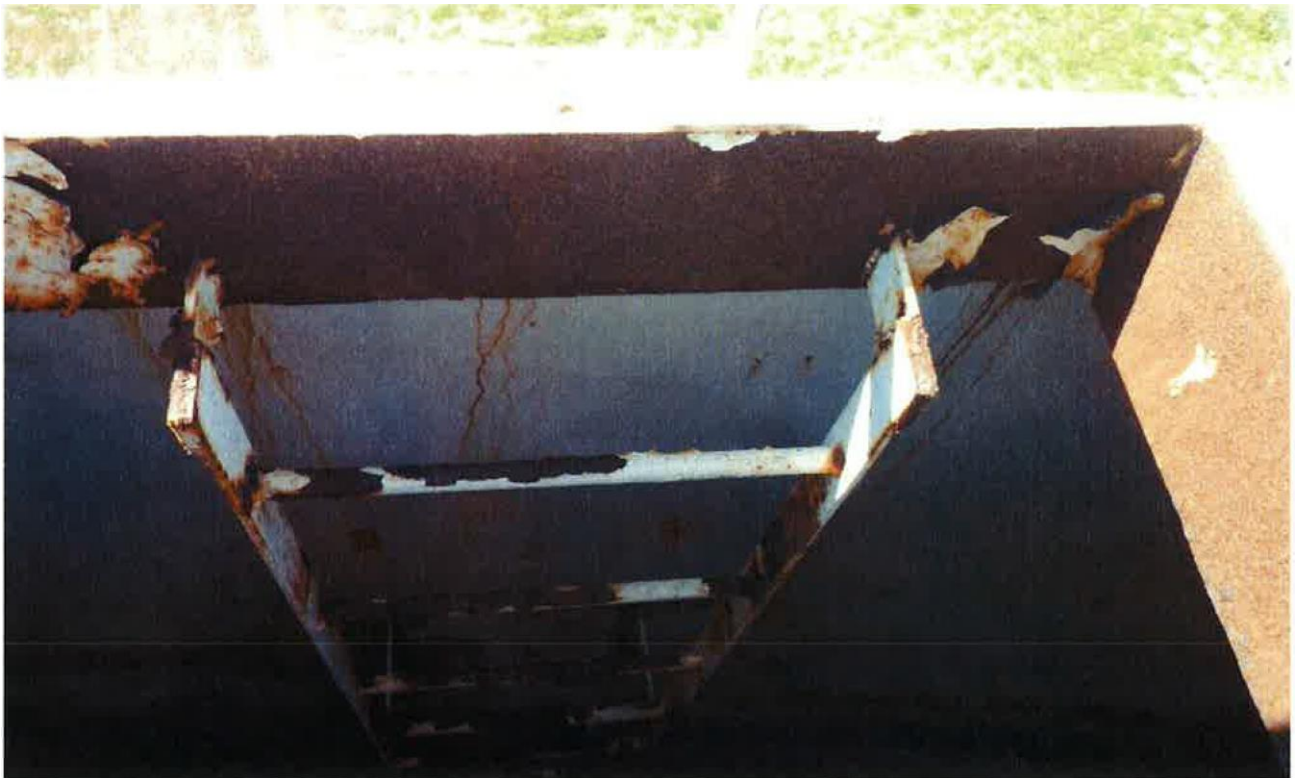
46. Roof manhole and interior ladder. Note corrosion.

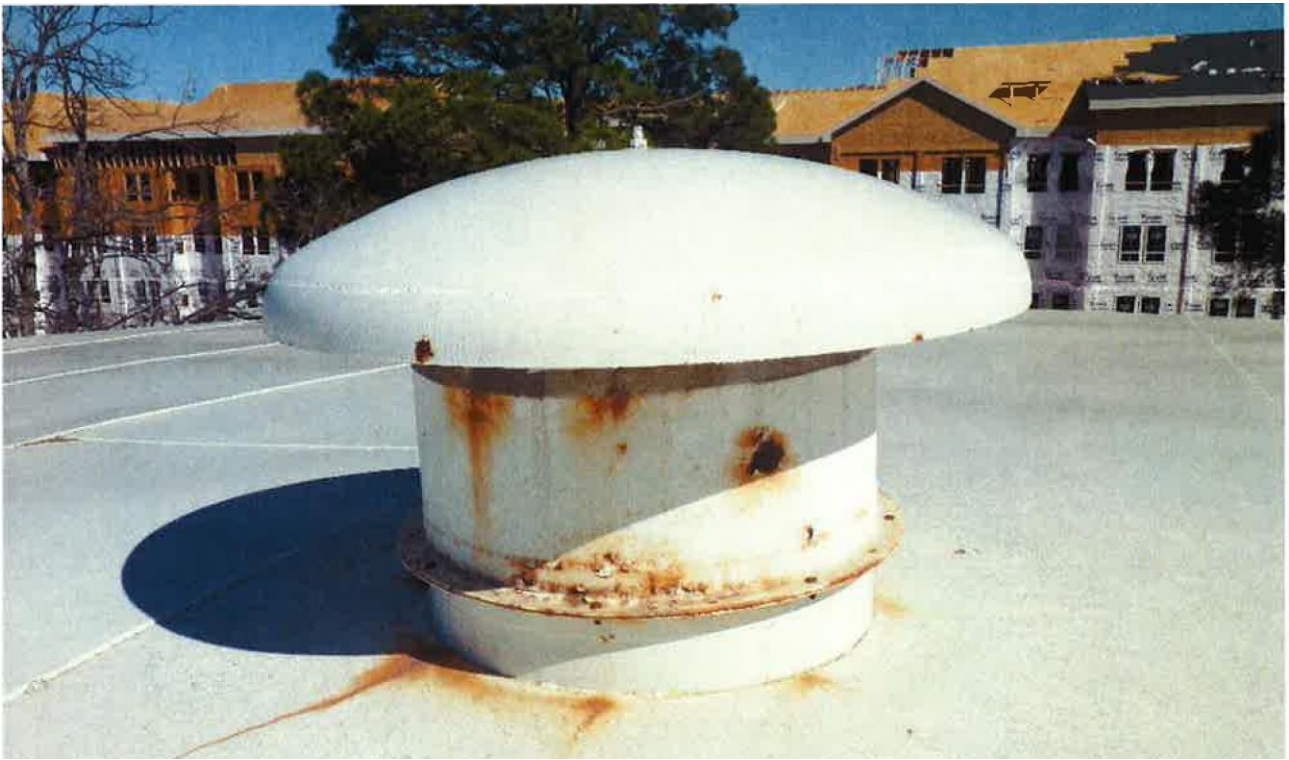
47. Roof vent. Note corrosion.

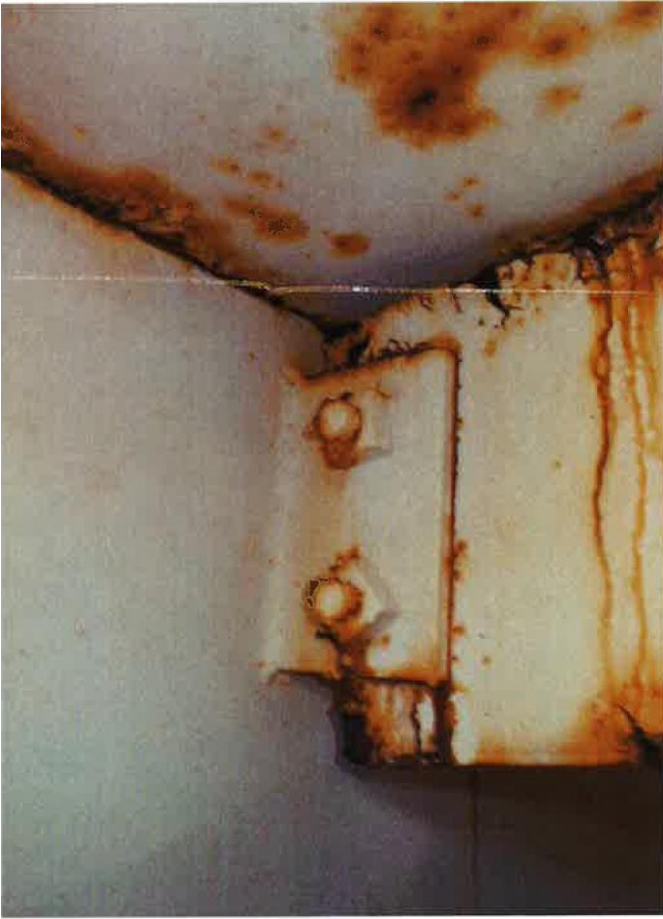
51. Corrosion and metal loss at rafter-to-clip connection.

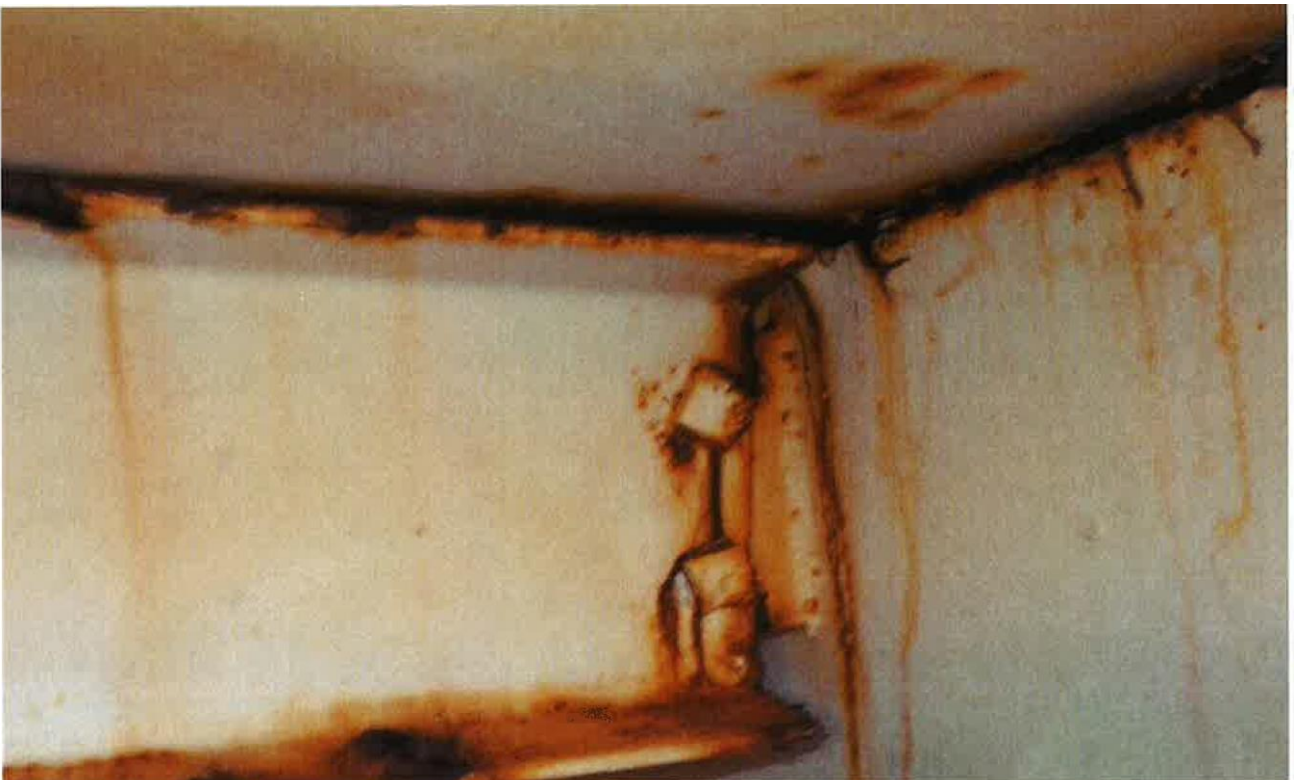
52. Corrosion and metal loss at rafter-to-clip connection.

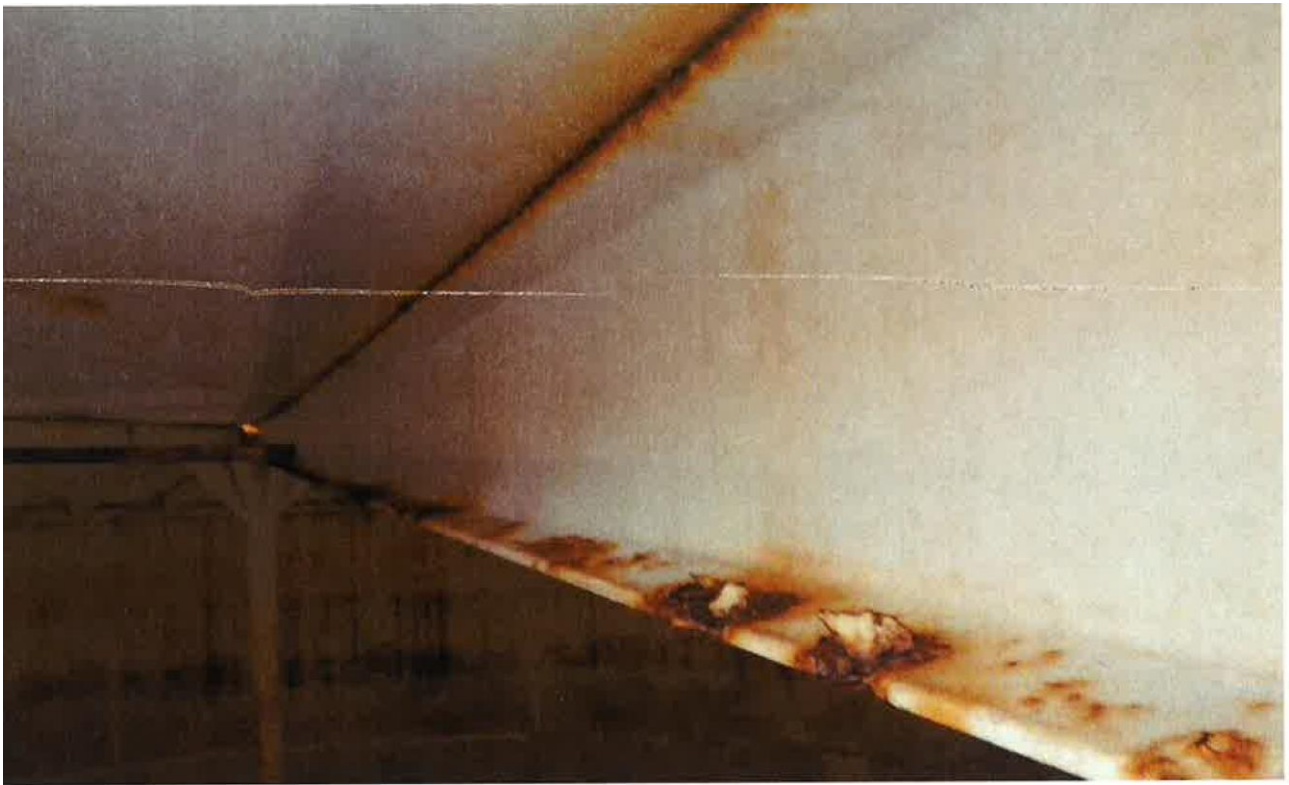
53. Corrosion and metal loss on roof rafter.

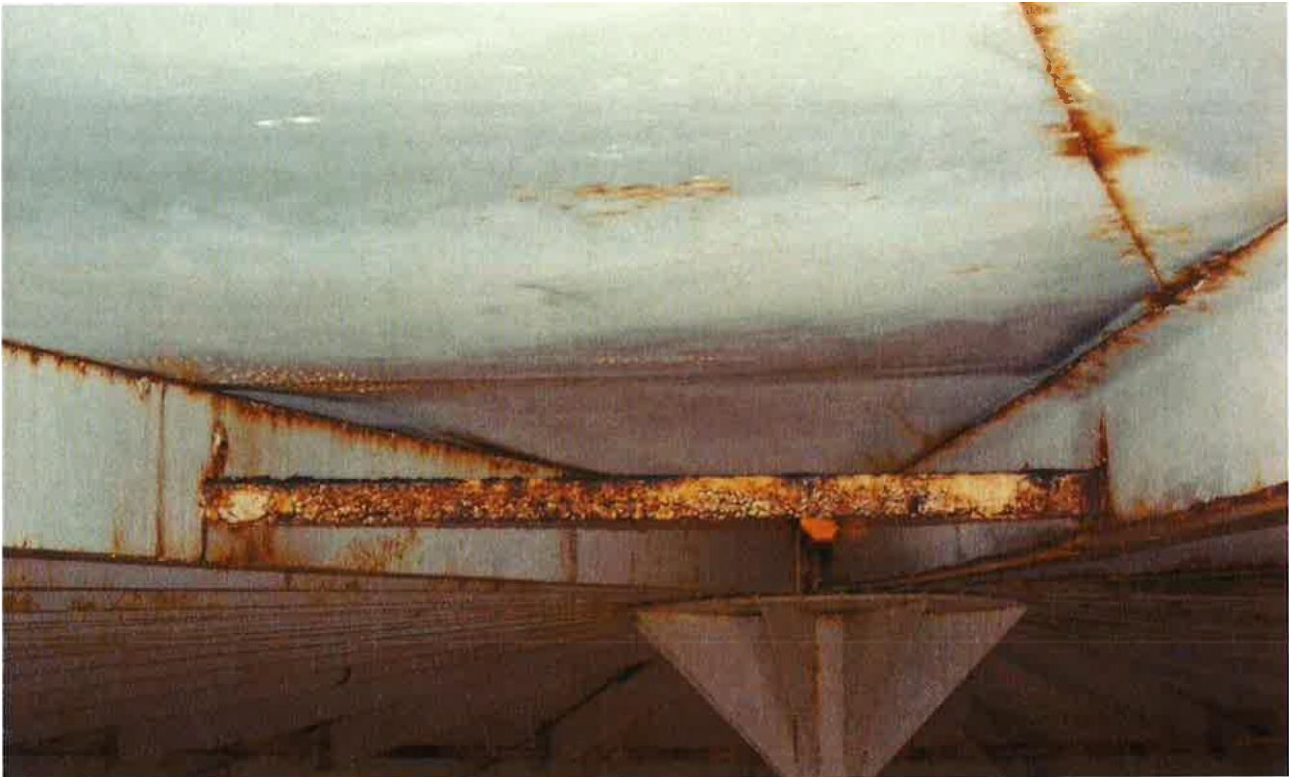
54. Corrosion and metal loss on purlin.

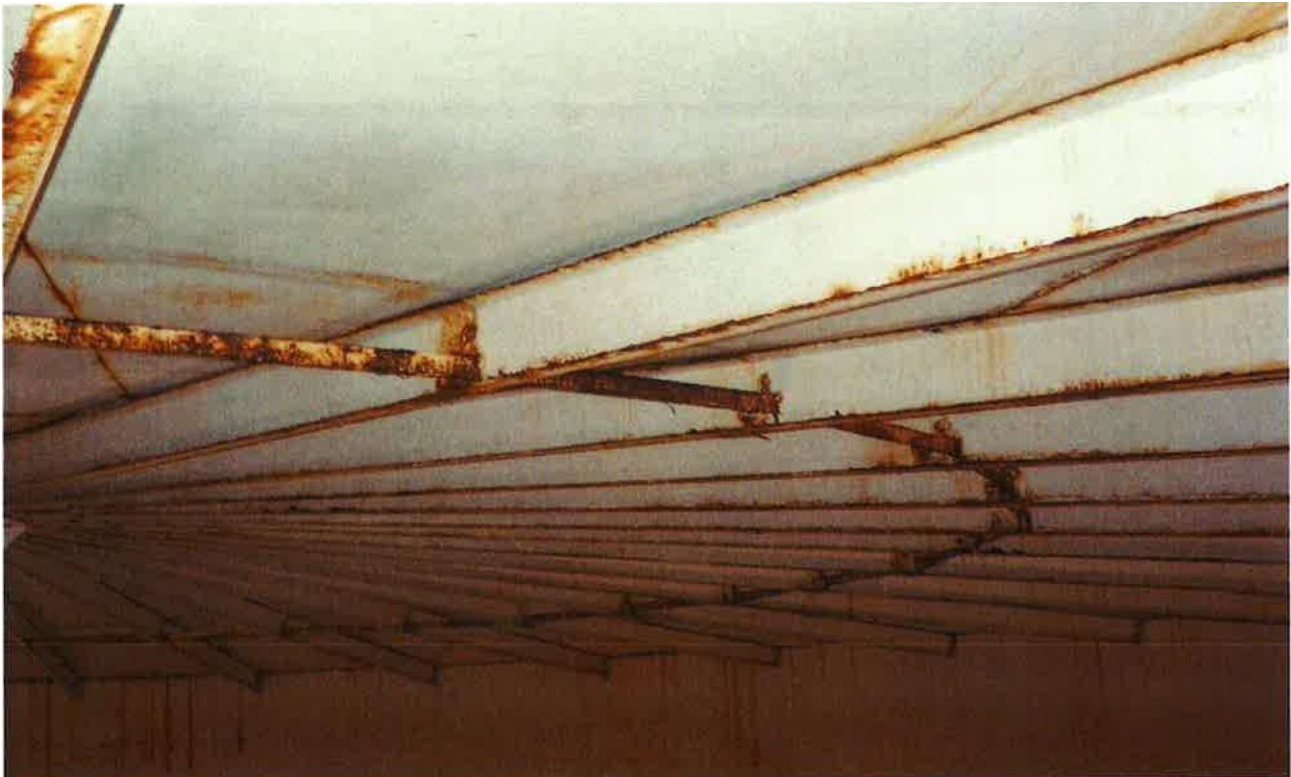
56. Roof support structure. Note corrosion and metal loss.

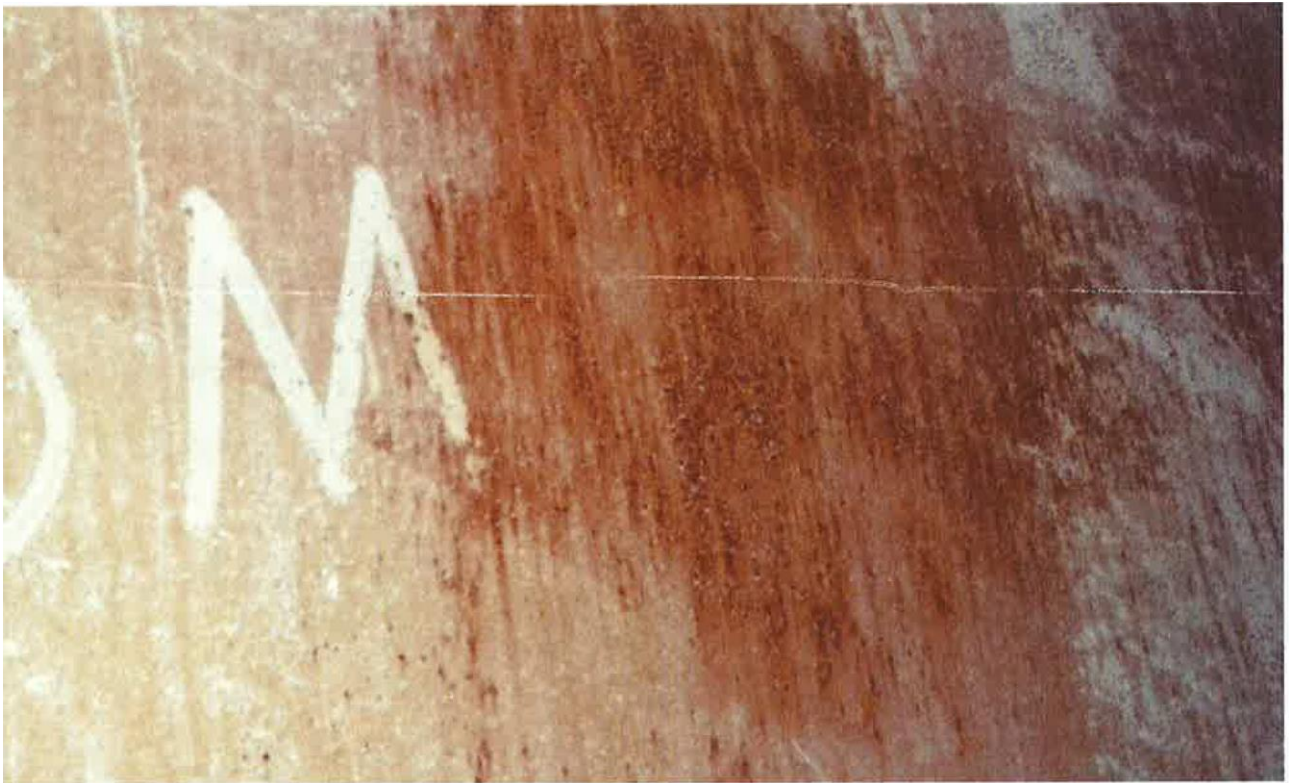
57. Corrosion on shell.

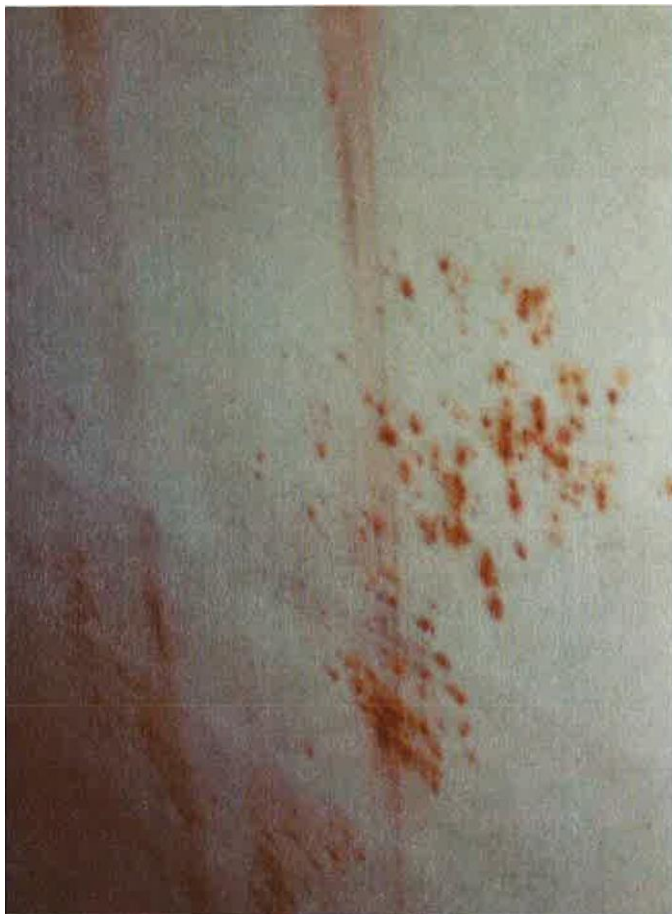
58. Corrosion on shell.

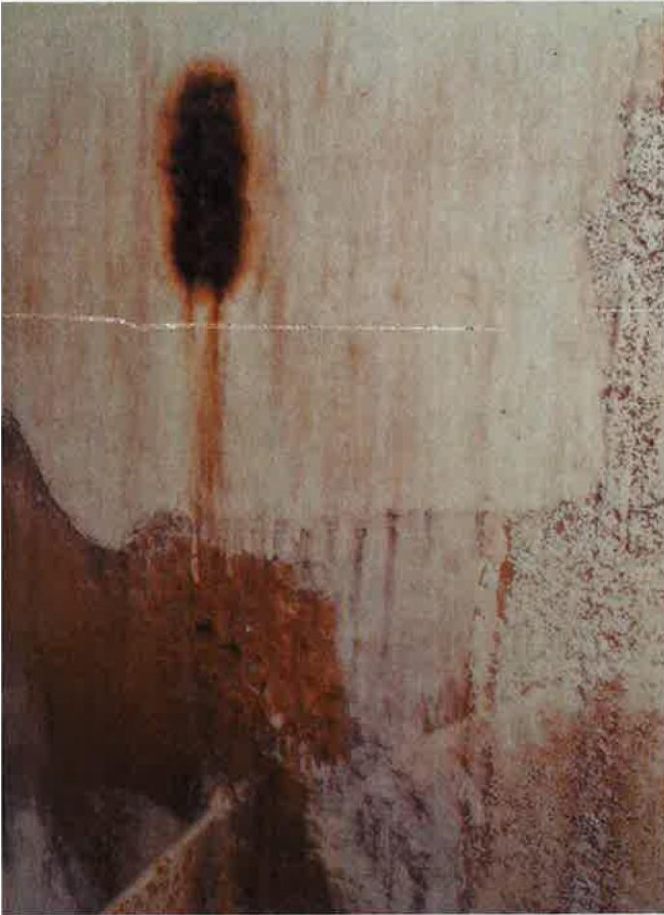
59. Area on shell damaged from exterior welding.
