Wastewater Collection System Evaluation Survey Basin 7 Final Report

December 2010

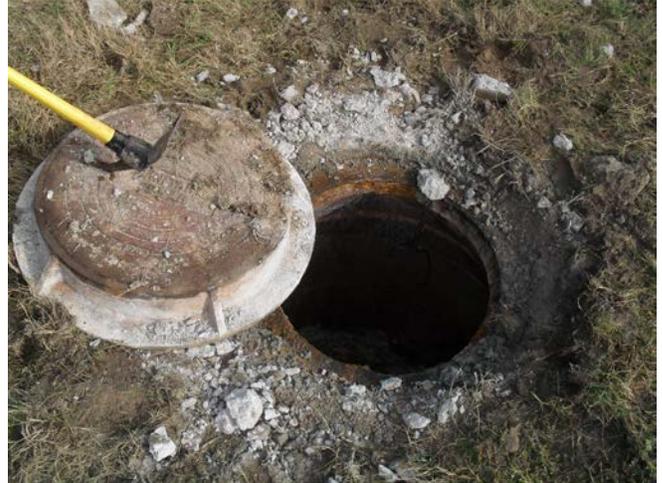
Manhole inspection was performed on all accessible manholes within the designated study area. Approximately 123 structures consisting of mainline cleanouts and manholes are within the study area. The following inspections were performed:

1. The casting/cone condition and manhole cover were evaluated for such items as vented covers that are in low ponding areas since casting/cone connection and covers are possible sources of inflow.
2. Manhole walls were checked for integrity and signs of root intrusion, deterioration of mortar joints, loose or missing bricks, signs of surcharge, etc.
3. The bench was checked for type and depth of debris, flow conditions thru the manhole and any signs of settlement that may impede the achievement of design flows.
4. Influent and effluent lines in each manhole were compared to existing maps and corrections noted.
5. Inspection of each influent and effluent line to determine line conditions.
6. Any silt deposits that reduces flow capacity were noted and depth of silt recorded.

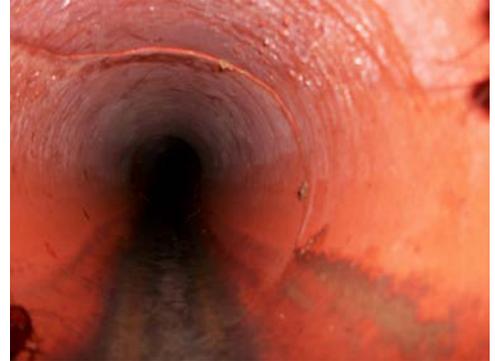
A listing of the Basin 7 mainline sewer inventory is included on the report CD. Each pipe entering and exiting the manhole was inspected and photographed. Internal color television inspection was undertaken on specific lines to visually establish the pipeline condition. Any structural problems or defects were digitally recorded along with a detailed log. The observation logs are presented in Appendix D and video files are included on the CCTV DVDs. Internal inspection of specific sewer lines determined the best repair options, which in turn, will reduce overall project costs. The total cost for repairs to municipal pipelines is estimated at \$505,649. Data collected during pipe inspections was also used to recommend a cleaning plan. Six line segments are recommended for cleaning at an estimated cost of \$14,720.
